PHOTOGRAPHIC INTELLIGENCE REPORT

STATUS OF NORTH VIETNAMESE RAILROADS

Report No. 17
CIA/PIR 75061

DATE Nov. 1966

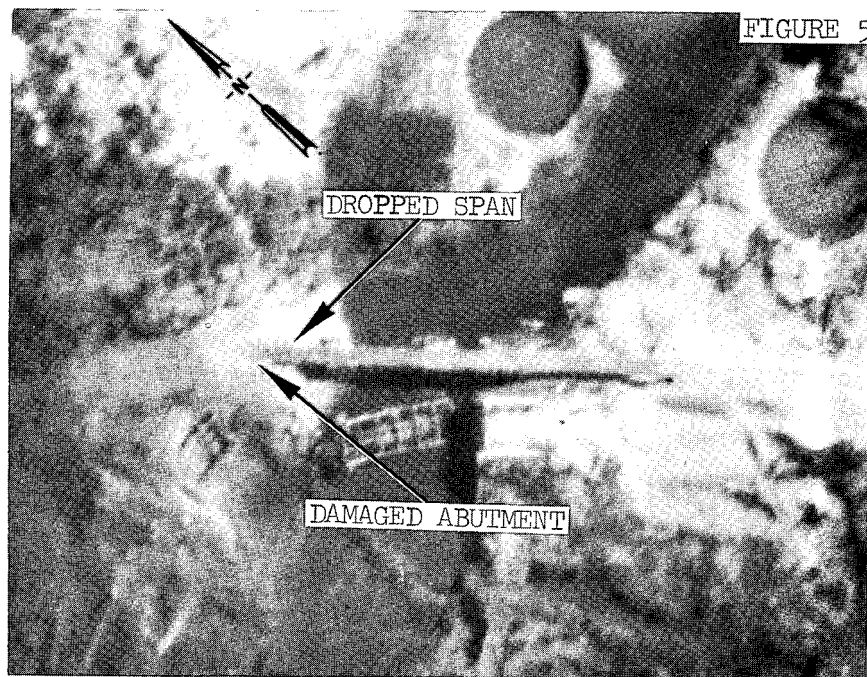
The 4-span, deck-type Lang Kay Railroad Bridge is unserviceable. One span has been partially dropped and 1 abutment has probably sustained heavy damage.

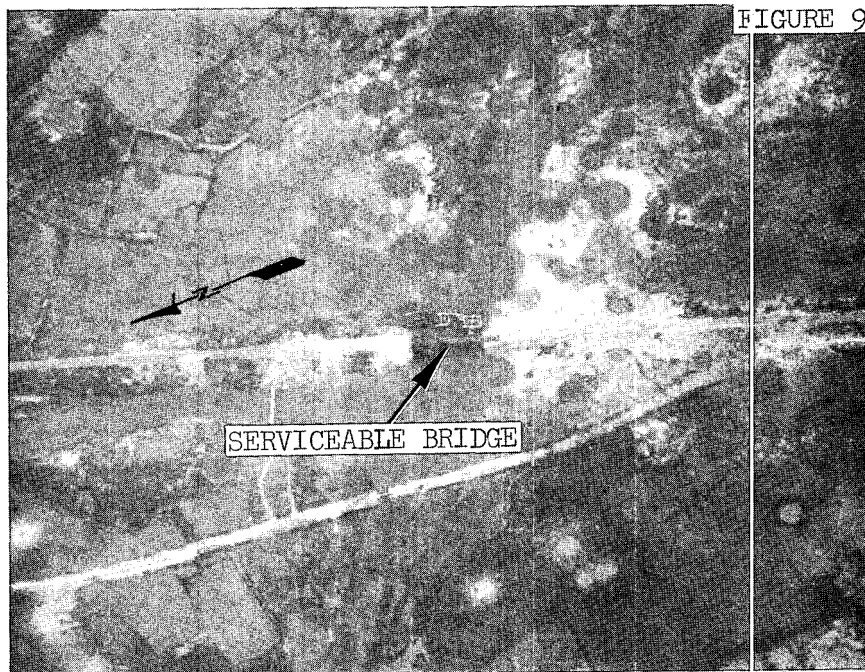
The 4-span, deck-beam Phu Quat Railroad Bridge has been repaired and is serviceable.

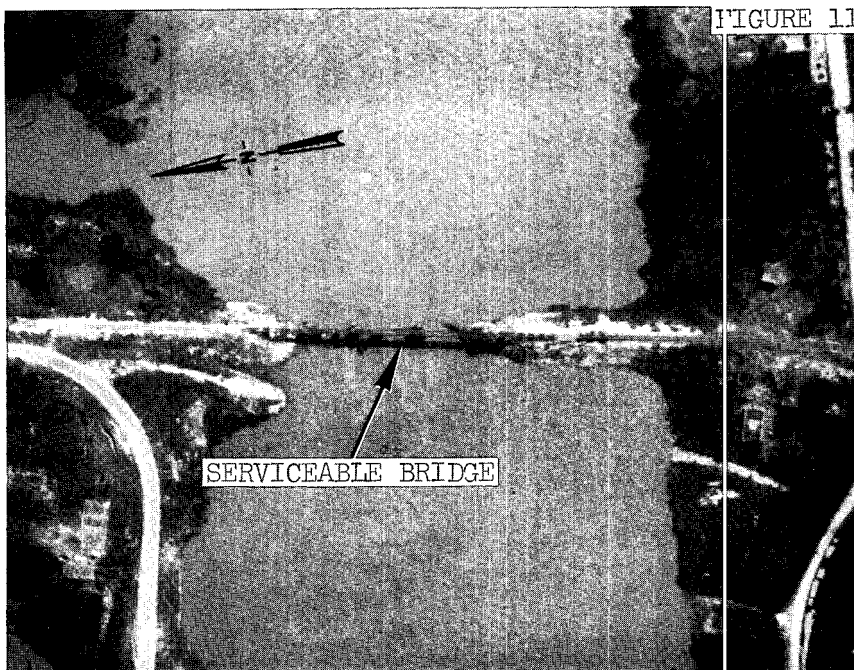
The multi-span, deck-beam Phu Ly Railroad Bridge has been repaired and is serviceable.

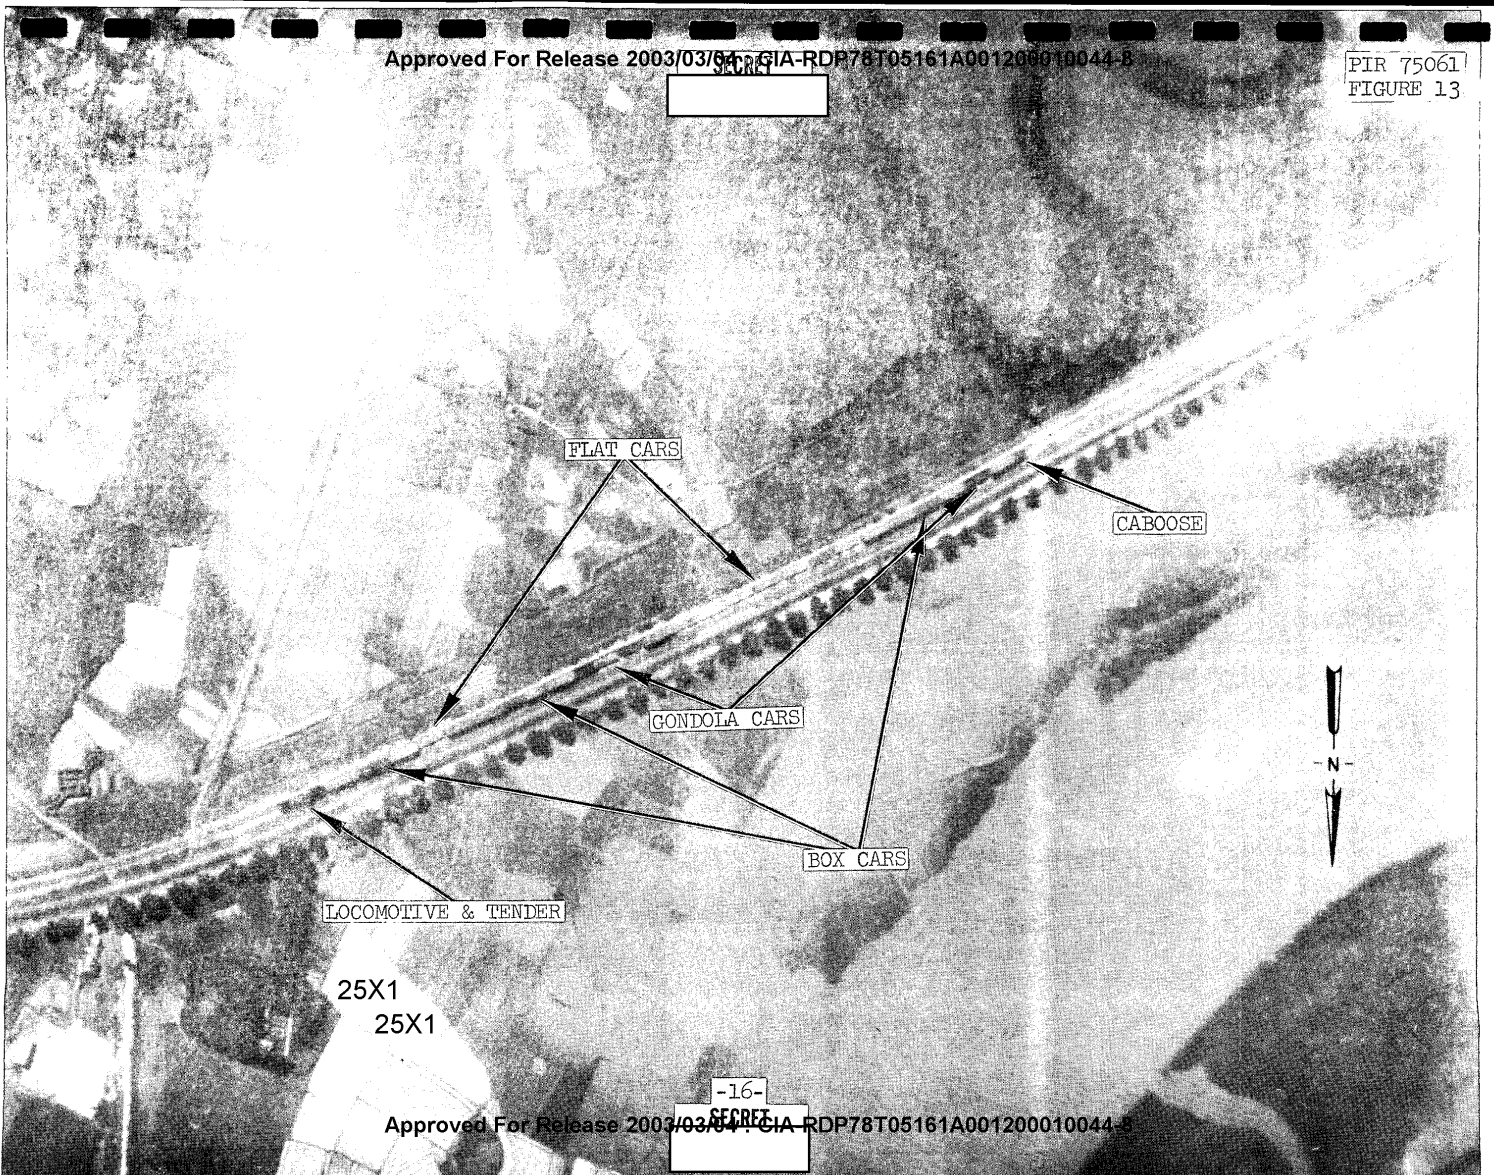
A motionless train composed of a locomotive and tender, 14 box cars, 8 flat cars, 4 gondola cars and a caboose was identified facing eastward toward Haiphong at UTM XJ 544197 on the Hanoi/Haiphong Rail Line. No cargo was noted on the flat cars or in the gondola cars.
